ELLIS ISLAND
STATUE OF LIBERTY NATIONAL MONUMENT
EXISTING CONDITION SURVEY
UNITS 2, 3 AND 4

Volume 4
Appendix A
Part Two

Beyer Blinder Belle/
Anderson Nottter Finegold

U.S. Department of the Interior / National Park Service

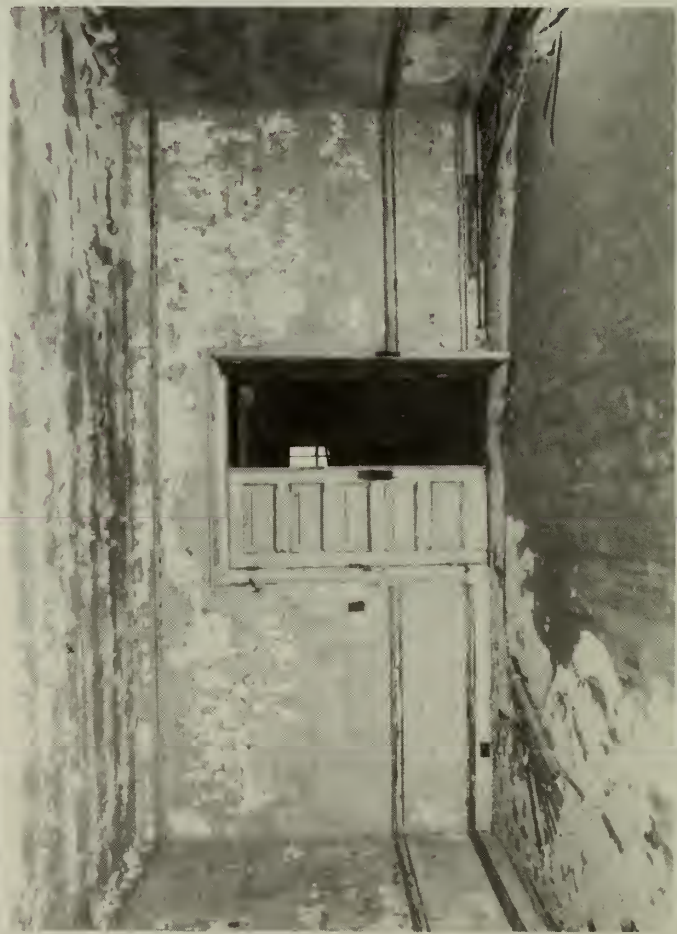
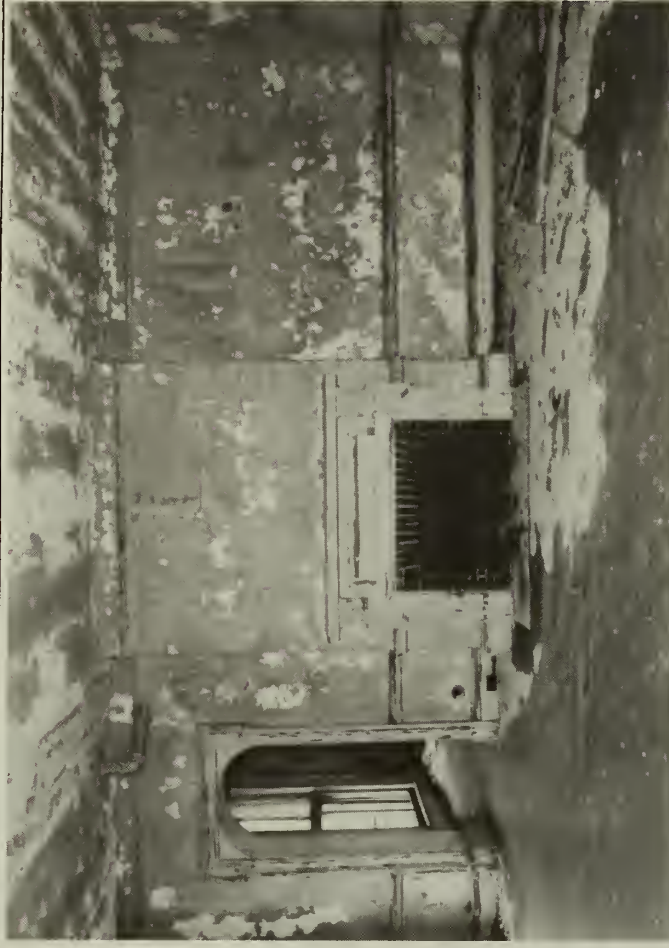
ROOM NO. 101

FINISHES:	CONDITION:	DATE:	NOTES:
FLOOR:	☒ Tile/Concrete Resilient ☒ Wood ☐ Other:	Good ☒ Fair ☐ Poor ☐ Destroyed	☒ 1911-1923 ☐ 1924-1933 ☐ 1934-present ☐ In question	
BASE:	☐ Tile/Concrete Resilient ☒ Wood ☐ Other:	Good ☒ Fair ☐ Poor ☐ Destroyed	☒ 1911-1923 ☐ 1924-1933 ☐ 1934-present ☐ In question	
WALLS:	☒ Plaster Partitions ☐ Tile Wainscot ☐ Other:	Good ☒ Fair ☐ Poor ☐ Destroyed	☒ 1911-1923 ☐ 1924-1933 ☐ 1934-present ☐ In question	Picture rail. chain rail.
CEILING:	☒ Plaster ☐ Acoustic panels ☐ Cove ☐ Other:	Good ☒ Fair ☐ Poor ☐ Destroyed	☒ 1911-1923 ☐ 1924-1933 ☐ 1934-present ☐ In question	
DOORS/ OPENINGS:	☒ Wood/Glass Panelled ☐ Wood Veneer ☐ Galvanized Metal ☐ Other:	Good ☒ Fair ☐ Poor ☐ Destroyed	☒ 1911-1923 ☐ 1924-1933 ☐ 1934-present ☐ In question	1 pair double 5-panel doors to hall. Windows have wood valance. evidence of venetian blinds.
LIGHTING:	☐ Incandescent/Type A ☐ Incandescent/Type B ☒ CML/Sconce ☐ Other:	☐ Intact ☐ Intact ☐ Intact ☐ Intact ☐ Destroyed ☐ Destroyed ☐ Destroyed ☐ Destroyed	☒ 1911-1923 ☐ 1924-1933 ☐ 1934-present ☐ In question	Evidence (flat metal caps in wall) of 9 removed sconces.

HEATING/ VENTILATION PLUMBING:	☒ Radiators ☐ Vents/Fans ☐ Sink/Toilet/Urinal ☐ Other:	☒ Intact ☐ Intact ☐ Intact ☐ Intact ☐ Destroyed ☐ Destroyed ☐ Destroyed ☐ Destroyed	☒ 1911-1923 ☐ 1924-1933 ☐ 1934-present ☐ In question	
MISCELLANEOUS:		☒ Good ☐ Fair ☐ Poor ☐ Destroyed	☒ 1911-1923 ☐ 1924-1933 ☐ 1934-present ☐ In question	Fireplace: Hearth - tile block. face - brick.
SUMMARY:		☒ Good ☐ Fair ☐ Poor ☐ Destroyed	☒ 1911-1923 ☐ 1924-1933 ☐ 1934-present ☐ In question	ARCHITECTURAL SIGNIFICANCE: ☒ Most ☐ Some ☐ Minor ☐ Negligible

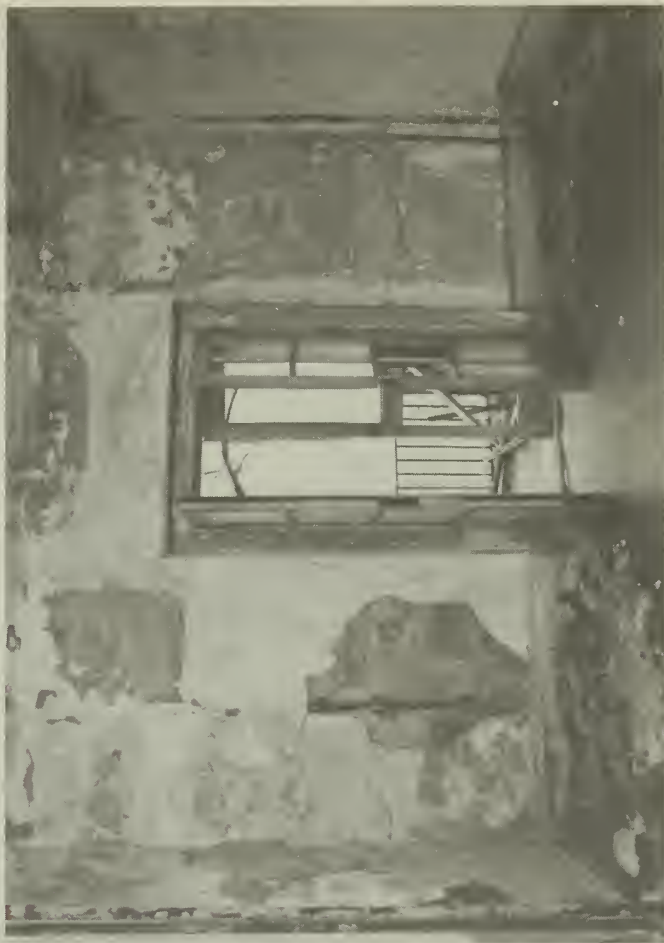
ROOM NO:	102	LAST KNOWN USE:	Kitchen	SQUARE FEET:	208	CEILING HEIGHT:		DATE:	25 Nov. 1985
		FINISHES:	CONDITION:	DATE:		NOTES:			
FLOOR:	☒ Tile/Concrete ☒ Resilient ☒ Wood ☒ Other:	☒ Good ☒ Fair ☒ Poor ☒ Destroyed	☒ 1911-1923 ☒ 1924-1933 ☒ 1934-present ☒ In question	Probable replacement boards - no indication of wall removal, as in plan.					
BASE:	☒ Tile/Concrete ☒ Resilient ☒ Wood ☒ Other:	☒ Good ☒ Fair ☒ Poor ☒ Destroyed	☒ 1911-1923 ☒ 1924-1933 ☒ 1934-present ☒ In question	Some rot in NE corner.					
WALLS:	☒ Plaster ☒ Partitions ☒ Tile Wainscot ☒ Other:	☒ Good ☒ Fair ☒ Poor ☒ Destroyed	☒ 1911-1923 ☒ 1924-1933 ☒ 1934-present ☒ In question	Cove at ceiling - not corners. Ghosts of alterations: door replacement; pantry removal; window infill.					
CEILING:	☒ Plaster ☒ Acoustic panels ☒ Cove ☒ Other:	☒ Good ☒ Fair ☒ Poor ☒ Destroyed	☒ 1911-1923 ☒ 1924-1933 ☒ 1934-present ☒ In question	Ghost of pantry wall on ceiling.

DOORS/ OPENINGS:	☒ Wood/Glass Panelled ☒ Wood Veneer ☒ Galvanized Metal ☒ Other: french doors	☒ Good ☒ Fair ☒ Poor ☒ Destroyed	☒ 1911-1923 ☒ 1924-1933 ☒ 1934-present ☒ In question	1 pair french doors sept: E. wall. Door removed = arched opening: W. wall. 3 panel door w/ altered wood infill light w/ diamond shaped glass light. (attached) to 102A.					
LIGHTING:	☒ Incandescent/Type A ☒ Incandescent/Type B ☒ CML/Sconce ☒ Other:	☒ Destroyed ☒ Destroyed ☒ Destroyed ☒ Destroyed	☒ 1911-1923 ☒ 1924-1933 ☒ 1934-present ☒ In question	Metal rod - approx. 2' w/ support for removed shade. Standard for staff House.					
HEATING/ VENTILATION PLUMBING:	☒ Radiators ☒ Vents/Fans ☒ Sink/Toilet/Urinal ☒ Other:	☒ Intact ☒ Intact ☒ Intact ☒ Intact	☒ 1911-1923 ☒ 1924-1933 ☒ 1934-present ☒ In question	none.					
MISCELLANEOUS:		☒ Good ☒ Fair ☒ Poor ☒ Destroyed	☒ 1911-1923 ☒ 1924-1933 ☒ 1934-present ☒ In question	cupboard w/ varnished interior where range used to be. Surrounds and this room are different from rest of bldg.

SUMMARY:		☒ Good ☒ Fair ☒ Poor ☒ Destroyed	☒ 1911-1923 ☒ 1924-1933 ☒ 1934-present ☒ In question	ARCHITECTURAL SIGNIFICANCE: ☐ Most ☐ Some ☒ Minor ☐ Negligible

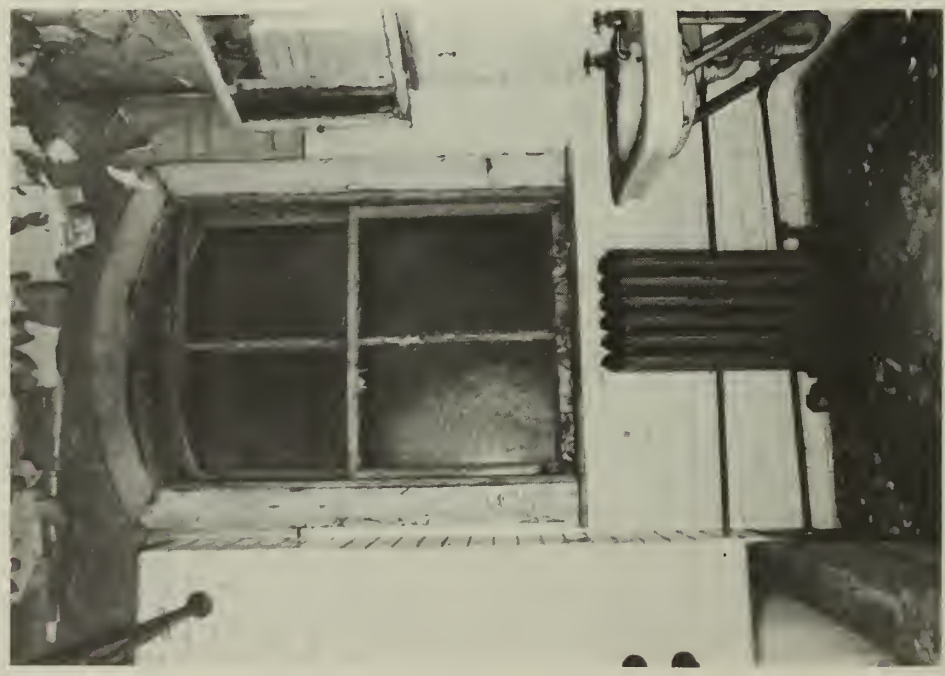
ELLIS ISLAND EXISTING CONDITION SURVEY				Staff House		page: 576			
ROOM NO: 203	LAST KNOWN USE: Bathroom		SQUARE FEET: 52	CEILING HEIGHT: 8'-11 1/4" DATE: 26 Nov. 1985					
	FINISHES:	CONDITION:	DATE:	NOTES:					
FLOOR:	☒ Tile/Concrete Resilient ☐ Wood ☐ Other:	☒ Good ☐ Fair ☐ Poor ☐ Destroyed	☒ 1911-1923 ☐ 1924-1933 ☐ 1934-present ☐ In question	Hexagonal white tiles.					
BASE:	☒ Tile/Concrete Resilient ☐ Wood ☐ Other:	☒ Good ☐ Fair ☐ Poor ☐ Destroyed	☒ 1911-1923 ☐ 1924-1933 ☐ 1934-present ☐ In question						
WALLS:	☐ Plaster ☐ Partitions ☒ Tile Wainscot ☐ Other:	☒ Good ☐ Fair ☐ Poor ☐ Destroyed	☒ 1911-1923 ☐ 1924-1933 ☐ 1934-present ☐ In question						
CEILING:	☒ Plaster ☐ Acoustic panels ☒ Cove ☐ Other:	☒ Good ☐ Fair ☐ Poor ☐ Destroyed	☒ 1911-1923 ☐ 1924-1933 ☐ 1934-present ☐ In question	cracking, NE corner.					
DOORS/ OPENINGS:	☒ Wood/Glass Panelled ☐ Wood Veneer ☐ Galvanized Metal ☐ Other:	☒ Good ☐ Fair ☐ Poor ☐ Destroyed	☒ 1911-1923 ☐ 1924-1933 ☐ 1934-present ☐ In question	Marble window and door sills. Dimpled glass windows

LIGHTING:	☐ Incandescent/Type A ☐ Incandescent/Type B ☒ CML Sconce 1 ☐ Other:	☐ Intact ☐ Intact ☐ Intact ☐ Intact ☐ Destroyed ☐ Destroyed ☐ Destroyed ☐ Destroyed	☐ 1911-1923 ☐ 1924-1933 ☒ 1934-present ☐ In question	1 oval ceramic sconce, no shade.					
HEATING/ VENTILATION PLUMBING:	☒ Radiators 1 ☐ Vents/Fans ☒ Sink/toilet/Urinal 1 ☒ Other: tub	☒ Intact ☐ Intact ☐ Intact ☐ Intact ☐ Destroyed ☐ Destroyed ☐ Destroyed ☐ Destroyed	☒ 1911-1923 ☐ 1924-1933 ☒ 1934-present ☐ In question	1 toilet w/ tank. 1 tub w/ shower + tiled back + tiled foot shelf. 1 wall mounted sink w/ faucets.					
MISCELLANEOUS:		☐ Good ☒ Fair ☐ Poor ☐ Destroyed	☐ 1911-1923 ☐ 1924-1933 ☐ 1934-present ☒ In question	Cream colored cloth window shade. 1 hanging wood cabinet w/ mirror. 1 toilet paper roller.					
SUMMARY:		☒ Good ☐ Fair ☐ Poor ☐ Destroyed	☒ 1911-1923 ☐ 1924-1933 ☐ 1934-present ☐ In question	ARCHITECTURAL SIGNIFICANCE:

PHOTOGRAPHS: ① view North

② toilet, SE corner.

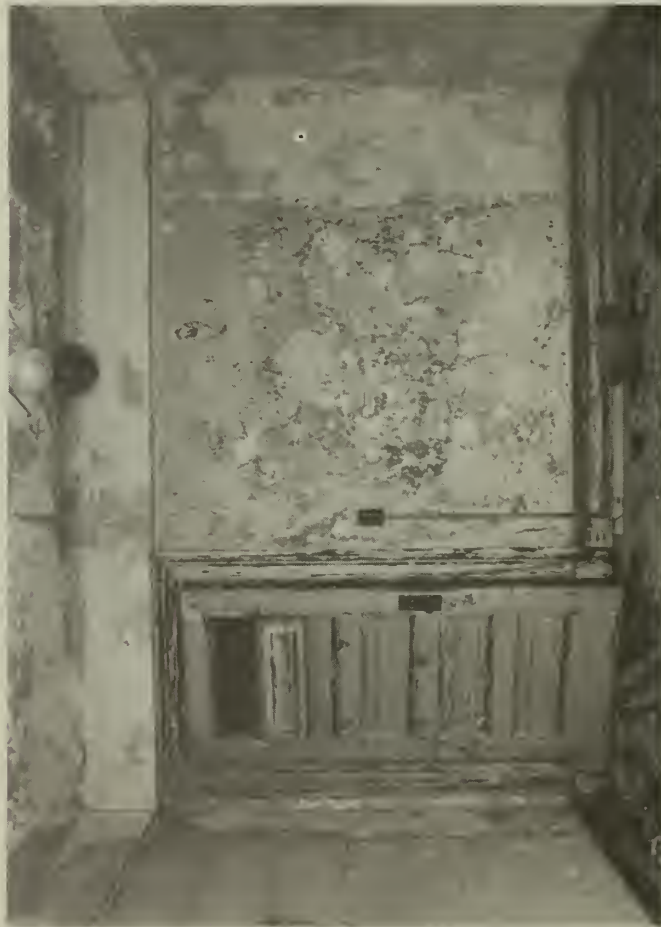
ELLIS ISLAND EXISTING CONDITION SURVEY				Staff House		page: 398			
ROOM NO: 204	LAST KNOWN USE: Bedroom		SQUARE FEET: 164	CEILING HEIGHT:	DATE: 26 Nov. 1985				
	FINISHES:	CONDITION:	DATE:	NOTES:					
FLOOR:	☐ Tile/Concrete ☒ Resilient ☒ Wood ☐ Other:	☐ Good ☒ Fair ☐ Poor ☐ Destroyed	☒ 1911-1923 ☐ 1924-1933 ☐ 1934-present ☐ In question	Weathered surface.					
BASE:	☐ Tile/Concrete ☐ Resilient ☒ Wood ☐ Other:	☐ Good ☒ Fair ☐ Poor ☐ Destroyed	☒ 1911-1923 ☐ 1924-1933 ☐ 1934-present ☐ In question	Some deterioration due to weathering thru opened windows.					
WALLS:	☒ Plaster ☐ Partitions ☐ Tile Wainscot ☐ Other:	☐ Good ☒ Fair ☐ Poor ☐ Destroyed	☒ 1911-1923 ☐ 1924-1933 ☐ 1934-present ☐ In question						
CEILING:	☒ Plaster ☐ Acoustic panels ☒ Cove ☐ Other:	☒ Good ☐ Fair ☐ Poor ☐ Destroyed	☒ 1911-1923 ☐ 1924-1933 ☐ 1934-present ☐ In question						
DOORS/ OPENINGS:	☒ Wood/ ~~Glass~~ Panelled ☐ Wood Veneer ☐ Galvanized Metal ☐ Other:	☒ Good ☐ Fair ☐ Poor ☐ Destroyed	☒ 1911-1923 ☐ 1924-1933 ☐ 1934-present ☐ In question	Door had hinged upper panel. Hooks on back of door. Venturian blinds: E. window. Drapery rod: N. window.

LIGHTING:	☐ Incandescent/Type A ☐ Incandescent/Type B ☒ CML ~~Scence~~ 2 ☒ Other: 1	☐ Intact ☐ Intact ☐ Intact ☐ Intact ☒ Destroyed ☐ Destroyed ☐ Destroyed ☐ Destroyed	☐ 1911-1923 ☐ 1924-1933 ☒ 1934-present ☐ In question	ghosts of 2 removed sconces. 1 standard picture - shade detached, on floor.					
HEATING/ VENTILATION PLUMBING:	☒ Radiators / ☐ Vents/Fans ☐ Sink/Toilet/Urinal ☐ Other:	☐ Intact ☐ Intact ☐ Intact ☐ Intact ☐ Destroyed ☐ Destroyed ☐ Destroyed	☒ 1911-1923 ☐ 1924-1933 ☐ 1934-present ☐ In question						
MISCELLANEOUS:		☐ Good ☐ Fair ☐ Poor ☐ Destroyed	☐ 1911-1923 ☐ 1924-1933 ☐ 1934-present ☐ In question						
SUMMARY:		☒ Good ☐ Fair ☐ Poor ☐ Destroyed	☒ 1911-1923 ☐ 1924-1933 ☒ 1934-present ☐ In question	ARCHITECTURAL SIGNIFICANCE:		☐ Most ☒ Some ☐ Minor ☐ Negligible

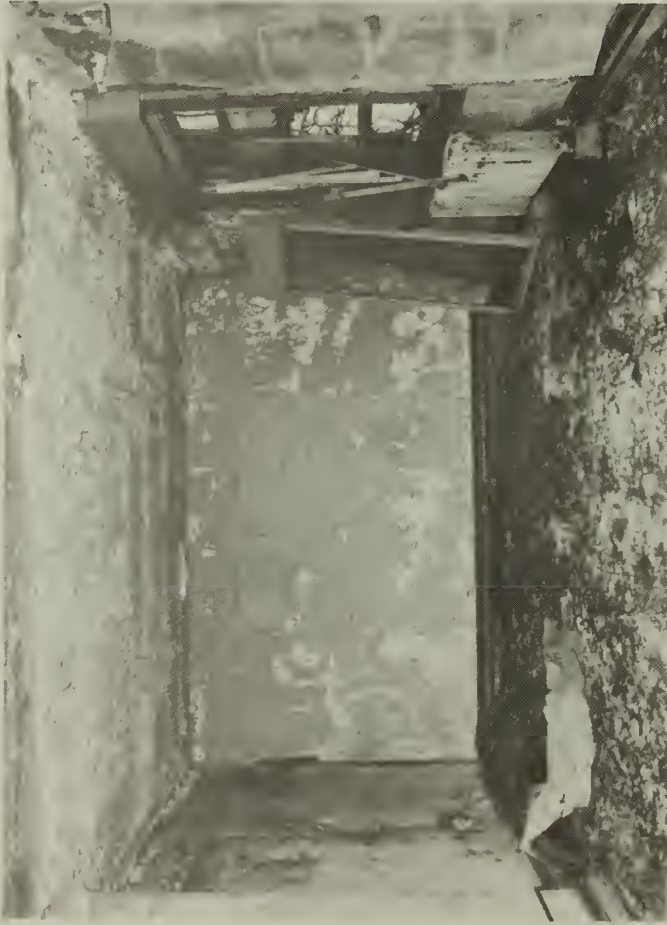
ELLIS ISLAND EXISTING CONDITION SURVEY Staff House page: 40Z			
ROOM NO: 206/207		LAST KNOWN USE: Bedroom	SQUARE FEET: 328
		CEILING HEIGHT:	DATE: 25 Nov. 1985
	FINISHES:	CONDITION:	DATE:
FLOOR:	☐ Tile/Concrete	☐ Good	☒ 1911-1923
	☒ Resilient	☒ Fair	☐ 1924-1933
	☒ Wood	☐ Poor	☐ 1934-present
	☐ Other:	☐ Destroyed	☐ In question
BASE:	☐ Tile/Concrete	☐ Good	☒ 1911-1923
	☐ Resilient	☒ Fair	☐ 1924-1933
	☒ Wood	☐ Poor	☐ 1934-present
	☐ Other:	☐ Destroyed	☐ In question
WALLS:	☒ Plaster	☐ Good	☒ 1911-1923
	☐ Partitions	☒ Fair	☐ 1924-1933
	☐ Tile Wainscot	☐ Poor	☐ 1934-present
	☐ Other:	☐ Destroyed	☐ In question
CEILING:	☒ Plaster	☐ Good	☒ 1911-1923
	☐ Acoustic panels	☒ Fair	☐ 1924-1933
	☒ Cove	☐ Poor	☐ 1934-present
	☐ Other:	☐ Destroyed	☐ In question
DOORS/ OPENINGS:	☒ Wood/ ~~Glass~~ Panelled	☐ Good	☒ 1911-1923
	☐ Wood Veneer	☒ Fair	☐ 1924-1933
	☐ Galvanized Metal	☐ Poor	☐ 1934-present
	☐ Other:	☐ Destroyed	☐ In question

LIGHTING:	☐ Incandescent/Type A	☐ Intact	☐ 1911-1923
	☐ Incandescent/Type B	☐ Intact	☐ 1924-1933
	☐ CML/Sconce	☐ Intact	☐ 1934-present
	☐ Other:	☐ Intact	☐ In question
HEATING/ VENTILATION PLUMBING:	☒ Radiators 2	☒ Intact	☒ 1911-1923
	☐ Vents/Fans	☐ Intact	☐ 1924-1933
	☐ Sink/Toilet/Urinal	☐ Intact	☐ 1934-present
	☐ Other:	☐ Intact	☐ In question
MISCELLANEOUS:	☐	☐ Good	☐ 1911-1923
	☐	☒ Fair	☐ 1924-1933
	☐	☐ Poor	☒ 1934-present
	☐	☐ Destroyed	☐ In question
SUMMARY:	☒	☐ Good	☒ 1911-1923
	☐	☐ Fair	☐ 1924-1933
	☐	☐ Poor	☒ 1934-present
	☐	☐ Destroyed	☐ In question
ARCHITECTURAL SIGNIFICANCE:			Most ☒ Some ☐ Minor ☐ Negligible
NOTES:			joint where wall was removed.

E. wall - cloth wall covering, "Wall-Tex" type. Overpainted w/ blue.
			ghost of removed wall.
			1 5-panel door, w. wall.
			Built-in closet w/ cupboards above and side cupboard: S.W. wall. (207A).

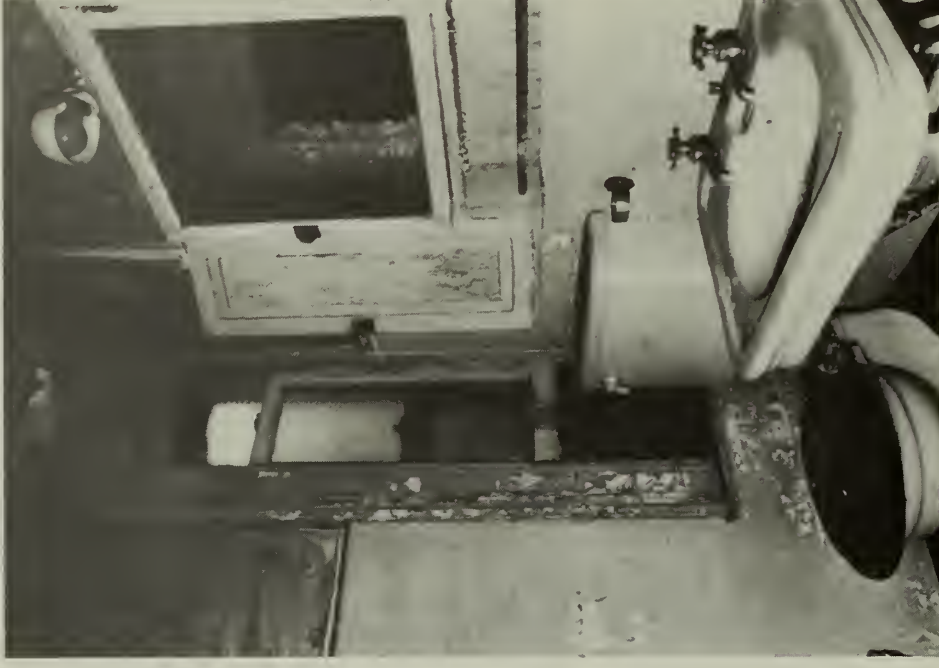
FINISHES:	CONDITION:	DATE:	NOTES:
FLOOR:	☒ Tile/Concrete ☒ Resilient ☐ Wood ☐ Other:	☒ Good ☐ Fair ☐ Poor ☐ Destroyed	1911-1923 1924-1933 1934-present In question	asphalt
BASE:	☒ Tile/Concrete ☒ Resilient ☐ Wood ☐ Other:	☒ Good ☐ Fair ☐ Poor ☐ Destroyed	1911-1923 1924-1933 1934-present In question	asphalt. Some areas detached.
WALLS:	☐ Plaster ☐ Partitions ☒ Tile Mainscot ☐ Other:	☒ Good ☐ Fair ☐ Poor ☐ Destroyed	1911-1923 1924-1933 1934-present In question	Tile overpainted. Silver wallpaper with flowers & waterfowl - on plaster above Mainscot.
CEILING:	☒ Plaster ☐ Acoustic panels ☒ Cove ☐ Other:	☒ Good ☐ Fair ☐ Poor ☐ Destroyed	1911-1923 1924-1933 1934-present In question	some delamination
DOORS/ OPENINGS:	☒ Wood/Glass Panelled ☐ Wood Veneer ☐ Galvanized Metal ☐ Other:	☐ Good ☐ Fair ☐ Poor ☐ Destroyed	1911-1923 1924-1933 1934-present In question	5 - panel door
LIGHTING:	☐ Incandescent/Type A ☐ Incandescent/Type B ☒ CML Sconce ☐ Other:	☐ Intact ☐ Intact ☐ Intact ☐ Intact ☐ Destroyed ☐ Destroyed ☐ Destroyed ☐ Destroyed	1911-1923 1924-1933 1934-present In question	with shade.

HEATING/ VENTILATION PLUMBING:	☒ Radiators ☐ Vents/Fans ☒ Sink/Toilet/Urinal ☒ Other: tubs	☐ Intact ☐ Intact ☐ Intact ☐ Intact ☐ Destroyed ☐ Destroyed ☐ Destroyed ☐ Destroyed	1911-1923 1924-1933 1934-present In question	1 toilet w/ tank 1 wall-hung sink w/ faucets. 1 tub w/ curved front, curtain rod.
MISCELLANEOUS:		☐ Good ☐ Fair ☐ Poor ☐ Destroyed	1911-1923 1924-1933 1934-present In question	2 glass holders as 208. 1 hanging cupboard as 208 w/ central mirror.
SUMMARY:		☒ Good ☐ Fair ☐ Poor ☐ Destroyed	1911-1923 1924-1933 1934-present In question	ARCHITECTURAL SIGNIFICANCE: Most ☐ Some ☐ Minor ☒ Negligible ☐

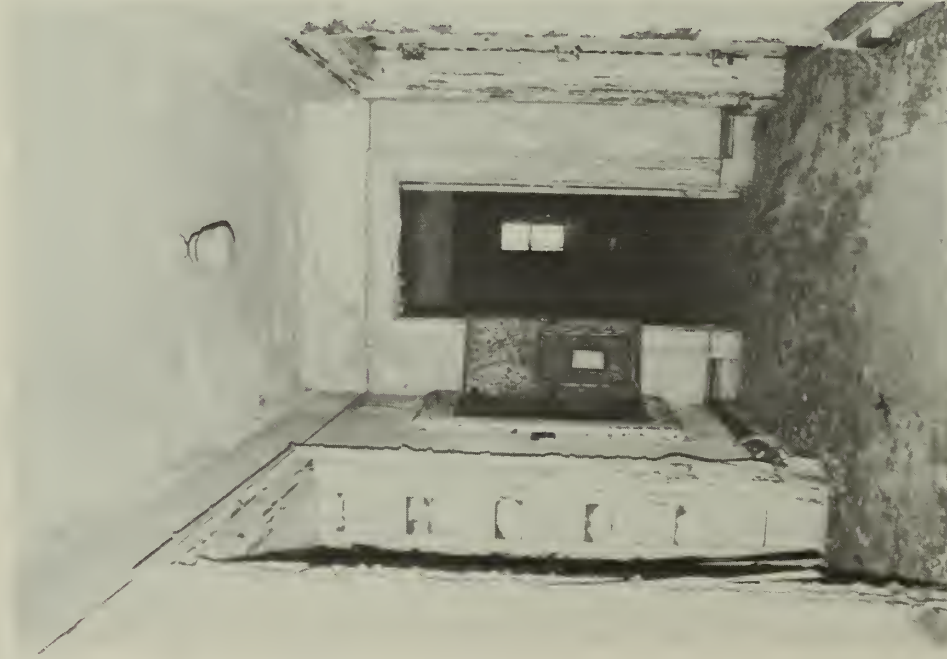
FINISHES:	CONDITION:	DATE:	NOTES:
FLOOR:	Tile/Concrete	☒ Good	☒ 1911-1923	
	Resilient	☐ Fair	☐ 1924-1933	
	Wood	☐ Poor	☐ 1934-present	
	Other:	☐ Destroyed	☐ In question	
BASE:	Tile/Concrete	☒ Good	☒ 1911-1923	
	Resilient	☐ Fair	☐ 1924-1933	
	Wood	☐ Poor	☐ 1934-present	
	Other:	☐ Destroyed	☐ In question	
WALLS:	Plaster	☒ Good	☒ 1911-1923	Picture rail.
	Partitions	☐ Fair	☐ 1924-1933	
	Tile Wainscot	☐ Poor	☐ 1934-present	
	Other:	☐ Destroyed	☐ In question	
CEILING:	Plaster	☒ Good	☒ 1911-1923	
	Acoustic panels	☐ Fair	☐ 1924-1933	
	Cove	☐ Poor	☐ 1934-present	
	Other:	☐ Destroyed	☐ In question	
DOORS/ OPENINGS:	Wood/ ~~Glass~~ Panelled	☒ Good	☒ 1911-1923	6 5-panel doors, panelled jambs.
	Wood Veneer	☒ Fair	☐ 1924-1933	
	Galvanized Metal	☐ Poor	☐ 1934-present	
	Other:	☐ Destroyed	☐ In question	
LIGHTING:	Incandescent/Type A	☐ Intact	☒ 1911-1923	glass globe.
	Incandescent/Type B	☐ Intact	☐ 1924-1933	
	CMU/Sconce 1	☐ Intact	☐ 1934-present

Other:	☒ Destroyed	☐ In question	
HEATING/ VENTILATION PLUMBING:	Radiators	☐ Intact	☐ 1911-1923	
	Vents/Fans	☐ Intact	☐ 1924-1933	
	Sink/Toilet/Urinal	☐ Intact	☒ 1934-present	
	Other:	☐ Intact	☐ In question	
MISCELLANEOUS:		☐ Good	☐ 1911-1923	1 circuit panel box: "#339" in brass on top.
		☐ Fair	☐ 1924-1933	
		☐ Poor	☐ 1934-present	
		☒ Destroyed	☐ In question	
SUMMARY:		☒ Good	☒ 1911-1923	ARCHITECTURAL SIGNIFICANCE:
		☐ Fair	☐ 1924-1933	
		☐ Poor	☒ 1934-present	
		☐ Destroyed	☐ In question	
			☐ Most	
			☒ Some	
			☐ Minor	
			☐ Negligible

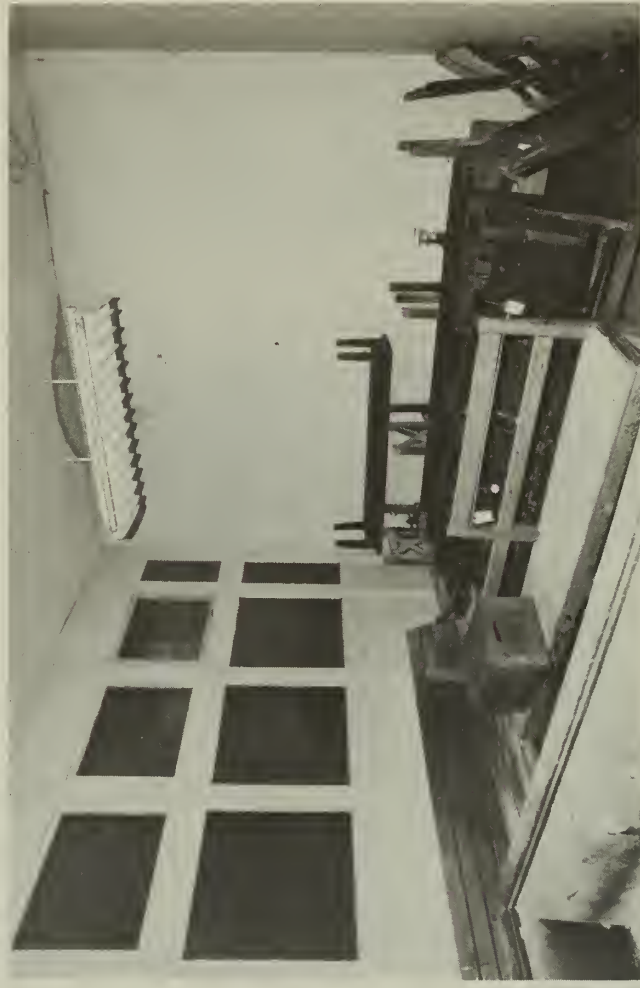
ROOM NO: 101 A, B, C,	LAST KNOWN USE: NPS office	SQUARE FEET: 258	CEILING HEIGHT: 258	DATE: 6 Dec. 1985	
	FINISHES:	CONDITION:	DATE:	NOTES:	
FLOOR:	☒ Tile/Concrete Resilient ☒ Wood ☒ Other:	☒ Good ☒ Fair ☐ Poor ☐ Destroyed	1911-1923 1924-1933 1934-present In question	Carpet over composite sheet-board. Remains in place.	
BASE:	☐ Tile/Concrete Resilient ☐ Wood ☒ Other: asphalt	☐ Good ☐ Fair ☒ Poor ☐ Destroyed	1911-1923 1924-1933 1934-present In question	Not on partition walls.	
WALLS:	☒ Plaster ☒ Partitions ☐ Tile Mainscot ☐ Other:	☒ Good ☐ Fair ☒ Poor ☐ Destroyed	1911-1923 1924-1933 1934-present In question	101A, E wall: severe surface chemical reaction and deterioration (with crusting, possible efflorescence). All partitions, good cond.	
CEILING:	☒ Plaster ☒ Acoustic panels ☐ Cove ☐ Other:	☒ Good ☐ Fair ☐ Poor ☐ Destroyed	1911-1923 1924-1933 1934-present In question		
DOORS/ OPENINGS:	☒ Wood/Glass Panelled ☒ Wood Veneer ☐ Galvanized Metal ☐ Other:	☐ Good ☒ Fair ☐ Poor ☐ Destroyed	1911-1923 1924-1933 1934-present In question	Doors removed from partition walls to 101c and 101D.

LIGHTING:	☐ Incandescent/Type A ☐ Incandescent/Type B ☐ CFL/Sconce ☒ Other: fluorescent	☐ Intact ☐ Intact ☐ Intact ☒ Destroyed	1911-1923 1924-1933 1934-present In question		
HEATING/ VENTILATION PLUMBING:	☒ Radiators ☐ Vents/Fans ☐ Sink/Toilet/Urinal ☐ Other:	☐ Intact ☐ Intact ☐ Intact ☐ Intact ☒ Destroyed	1911-1923 1924-1933 1934-present In question		
MISCELLANEOUS:		☐ Good ☐ Fair ☐ Poor ☐ Destroyed	1911-1923 1924-1933 1934-present In question	Door signage from H101: "VOCATIONAL"	
SUMMARY:		☐ Good ☒ Fair ☐ Poor ☐ Destroyed	1911-1923 1924-1933 1934-present In question	ARCHITECTURAL SIGNIFICANCE:	☐ Most ☐ Some ☒ Minor ☐ Negligible

PHOTOGRAPHS: ① 101A, view SW. ② 101B, view S. ③ 101D, view S. ④ 101D, NE ROOM NO. 101/A, EXC 1

PHOTOGRAPHS: ⑤ 101c, view S.E. ⑥ 101c, South ⑦ 101c, North ROOM NO. 101c

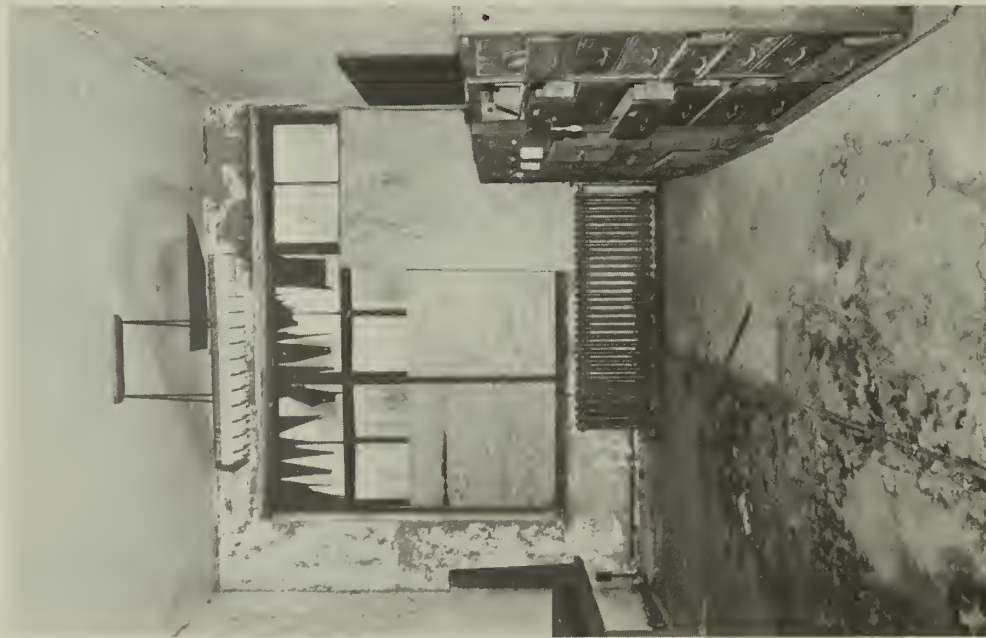
FINISHES:	CONDITION:	DATE:	NOTES:
FLOOR:	☒ Tile/Concrete ☒ Resilient <i>rolled</i> ☐ Wood ☐ Other:	☐ Good ☐ Fair ☒ Poor ☐ Destroyed	☐ 1911-1923 ☐ 1924-1933 ☒ 1934-present ☐ In question	
BASE:	☒ Tile/Concrete ☐ Resilient ☐ Wood ☐ Other:	☒ Good ☐ Fair ☐ Poor ☐ Destroyed	☐ 1911-1923 ☐ 1924-1933 ☒ 1934-present ☐ In question	
WALLS:	☒ Plaster ☐ Partitions ☐ Tile Mainscot ☐ Other:	☒ Good ☐ Fair ☐ Poor ☐ Destroyed	☐ 1911-1923 ☐ 1924-1933 ☒ 1934-present ☐ In question	
CEILING:	☒ Plaster ☐ Acoustic panels ☐ Cove ☐ Other	☐ Good ☒ Fair ☐ Poor ☐ Destroyed	☐ 1911-1923 ☐ 1924-1933 ☒ 1934-present ☐ In question	Water stains and hole.
DOORS/ OPENINGS:	☒ Wood/Glass Panelled ☐ Wood Veneer 1 ☐ Galvanized Metal ☐ Other:	☐ Good ☐ Fair ☒ Poor ☐ Destroyed	☐ 1911-1923 ☐ 1924-1933 ☒ 1934-present ☐ In question	Missing lower.
LIGHTING:	☐ Incandescent/Type A ☐ Incandescent/Type B ☐ CML/Sconce ☒ Other: <i>fluorescent</i>	☐ Intact ☐ Intact ☐ Intact ☐ Intact ☒ Destroyed ☐ Destroyed ☐ Destroyed ☐ Destroyed	☐ 1911-1923 ☐ 1924-1933 ☒ 1934-present ☐ In question

HEATING/ VENTILATION PLUMBING:	☒ Radiators ☐ Vents/Fans ☐ Sink/Toilet/Urinal ☐ Other:	☐ Intact ☐ Intact ☐ Intact ☐ Intact ☐ Destroyed ☐ Destroyed ☐ Destroyed ☐ Destroyed	☐ 1911-1923 ☐ 1924-1933 ☒ 1934-present ☐ In question	
MISCELLANEOUS:		☐ Good ☐ Fair ☐ Poor ☐ Destroyed	☐ 1911-1923 ☐ 1924-1933 ☐ 1934-present ☐ In question	
SUMMARY:		☐ Good ☒ Fair ☐ Poor ☐ Destroyed	☐ 1911-1923 ☐ 1924-1933 ☒ 1934-present ☐ In question	ARCHITECTURAL SIGNIFICANCE:
				Most Some Minor Negligible

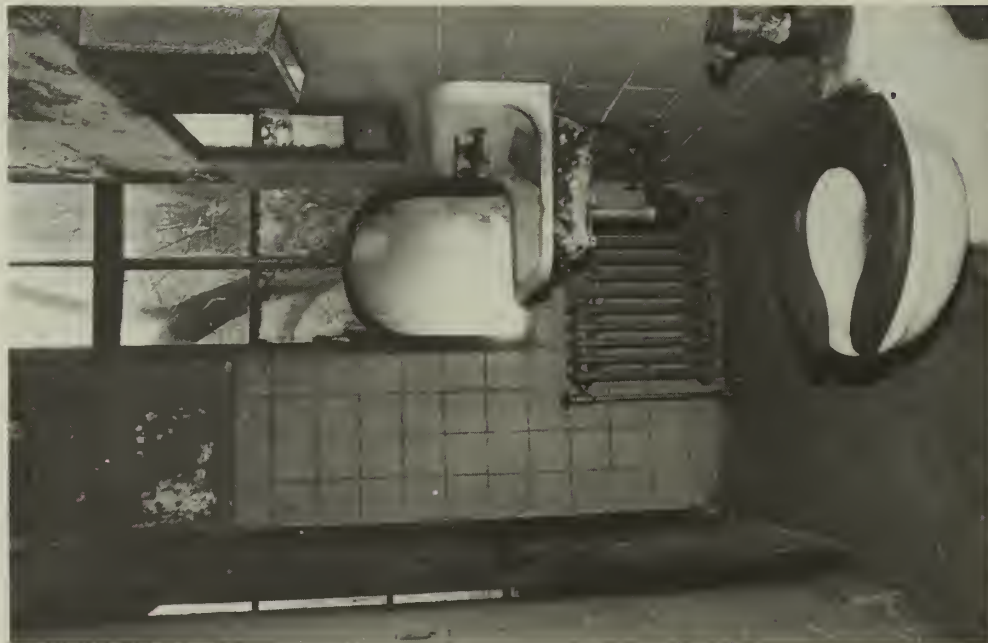
ROOM NO: 104B	LAST KNOWN USE: Bathroom	SQUARE FEET: 43	CEILING HEIGHT: 8	DATE: 2 Jan. 1986	NOTES:
FLOOR:	FINISHES: ☒ Tile ☒ Concrete ☐ Resilient ☐ Wood ☐ Other:	CONDITION: ☒ Good ☐ Fair ☐ Poor ☐ Destroyed	DATE: 1911-1923 1924-1933 1934-present In question		
BASE:	FINISHES: ☒ Tile ☒ Concrete ☐ Resilient ☐ Wood ☐ Other:	CONDITION: ☒ Good ☐ Fair ☐ Poor ☐ Destroyed	DATE: 1911-1923 1924-1933 1934-present In question		
WALLS:	Plaster ☐ Partitions ☒ Tile Wainscot ☐ Other:	CONDITION: ☒ Good ☐ Fair ☐ Poor ☐ Destroyed	DATE: 1911-1923 1924-1933 1934-present In question		
CEILING:	Plaster ☒ Acoustic panels ☐ Cove ☐ Other:	CONDITION: ☒ Good ☐ Fair ☐ Poor ☐ Destroyed	DATE: 1911-1923 1924-1933 1934-present In question		
DOORS/ OPENINGS:	Wood/Glass Panelled ☒ Wood Veneer ☐ Galvanized Metal ☐ Other:	CONDITION: ☒ Good ☐ Fair ☐ Poor ☐ Destroyed	DATE: 1911-1923 1924-1933 1934-present In question		
LIGHTING:	Incandescent/Type A ☐ Incandescent/Type B ☐ CML/Sconce ☒ Other:	Destroyed ☐ Destroyed ☐ Destroyed ☐ Destroyed	DATE: 1911-1923 1924-1933 1934-present In question		Standard Immigrant Building bathroom light fixture w/ fluted glass shade.

HEATING/ VENTILATION PLUMBING:	Radiators ☒ Vents/Fans ☒ Sink/Toilet/Urinal ☒ Other: Shower	Destroyed ☐ Destroyed ☐ Destroyed ☐ Destroyed	DATE: 1911-1923 1924-1933 1934-present In question		1 toilet. 1 slop sink: wall mounted. 1 shower: plumbing destroyed.
MISCELLANEOUS:		Good ☐ Fair ☐ Poor ☐ Destroyed	DATE: 1911-1923 1924-1933 1934-present In question		2 mirrors w/ wood frames. 1 rusted paper towel dispenser.
SUMMARY:	FINISHES: ☒ Good ☐ Fair ☐ Poor ☐ Destroyed	CONDITION: ☒ Good ☐ Fair ☐ Poor ☐ Destroyed	DATE: 1911-1923 1924-1933 1934-present In question		ARCHITECTURAL SIGNIFICANCE: Most Some Minor Negligible

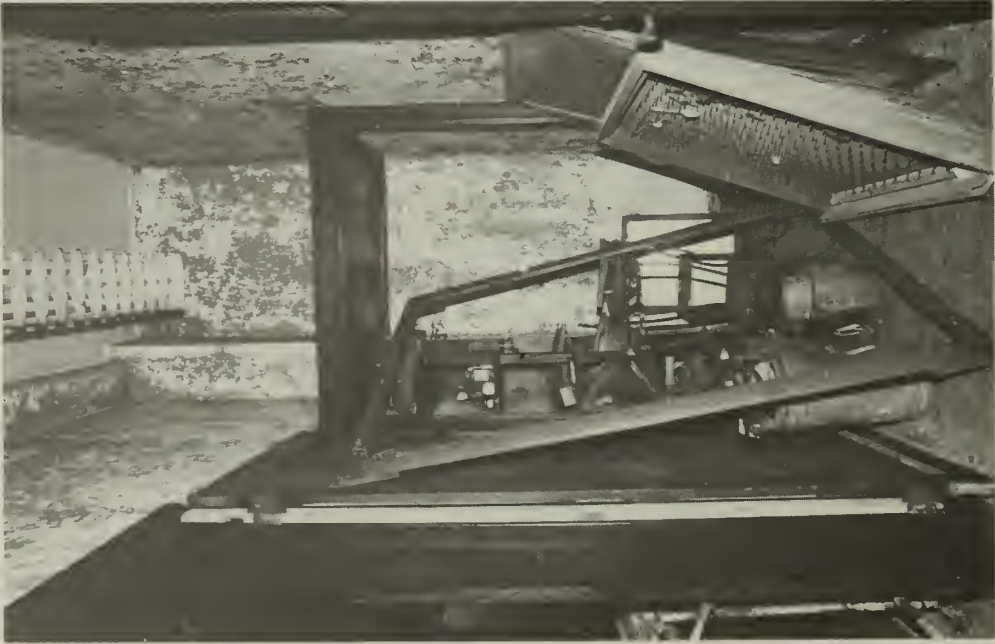
ROOM NO:	LAST KNOWN USE:	SQUARE FEET:	CEILING HEIGHT:	DATE:	NOTES:
106A	storage closet	47		2 Jan. 1986	
FLOOR:	FINISHES:	CONDITION:	DATE:		
	☒ Tile/Concrete ☒ Resilient rolled ☐ Wood ☐ Other:	☐ Good ☒ Fair ☐ Poor ☐ Destroyed	☐ 1911-1923 ☐ 1924-1933 ☒ 1934-present ☐ In question		
BASE:	FINISHES:	CONDITION:	DATE:		
	☒ Tile/Concrete ☒ Resilient ☐ Wood ☐ Other:	☐ Good ☒ Fair ☐ Poor ☐ Destroyed	☐ 1911-1923 ☐ 1924-1933 ☒ 1934-present ☐ In question		
WALLS:	FINISHES:	CONDITION:	DATE:		
	☒ Plaster ☐ Partitions ☐ Tile Wainscot ☐ Other:	☒ Good ☐ Fair ☐ Poor ☐ Destroyed	☐ 1911-1923 ☐ 1924-1933 ☒ 1934-present ☐ In question		
CEILING:	FINISHES:	CONDITION:	DATE:		
	☒ Plaster ☐ Acoustic panels ☐ Cove ☐ Other:	☒ Good ☐ Fair ☐ Poor ☐ Destroyed	☐ 1911-1923 ☐ 1924-1933 ☒ 1934-present ☐ In question		
DOORS/ OPENINGS:	FINISHES:	CONDITION:	DATE:		
	☐ Wood/Glass Panelled ☒ Wood Veneer 2 ☐ Galvanized Metal ☒ Other:	☐ Good ☒ Fair ☐ Poor ☐ Destroyed	☐ 1911-1923 ☐ 1924-1933 ☒ 1934-present ☐ In question	screen door to 106, in addition to wood veneer door.

LIGHTING:	FINISHES:	CONDITION:	DATE:		
	☐ Incandescent/Type A ☐ Incandescent/Type B ☐ CML/Scqnce ☒ Other: fluorescent	☐ Intact ☐ Intact ☐ Intact ☐ Intact ☐ Destroyed ☐ Destroyed ☐ Destroyed ☐ Destroyed	☐ 1911-1923 ☐ 1924-1933 ☒ 1934-present ☐ In question		
HEATING/ VENTILATION PLUMBING:	FINISHES:	CONDITION:	DATE:		
	☐ Radiators ☐ Vents/Fans ☐ Sink/Toilet/Urinal ☐ Other:	☐ Intact ☐ Intact ☐ Intact ☐ Intact ☐ Destroyed ☐ Destroyed ☐ Destroyed ☐ Destroyed	☐ 1911-1923 ☐ 1924-1933 ☐ 1934-present ☐ In question		
MISCELLANEOUS:	FINISHES:	CONDITION:	DATE:		
	☒ Good ☐ Fair ☐ Poor ☐ Destroyed	☐ Good ☐ Fair ☐ Poor ☐ Destroyed	☐ 1911-1923 ☐ 1924-1933 ☒ 1934-present ☐ In question	Built-in loft w/ shelves.	
SUMMARY:	FINISHES:	CONDITION:	DATE:	ARCHITECTURAL SIGNIFICANCE:	Most Some Minor Negligible
	☒ Good ☐ Fair ☐ Poor ☐ Destroyed	☐ Good ☐ Fair ☐ Poor ☐ Destroyed	☐ 1911-1923 ☐ 1924-1933 ☐ 1934-present ☐ In question	ARCHITECTURAL SIGNIFICANCE:	☐ Most ☐ Some ☒ Minor ☐ Negligible

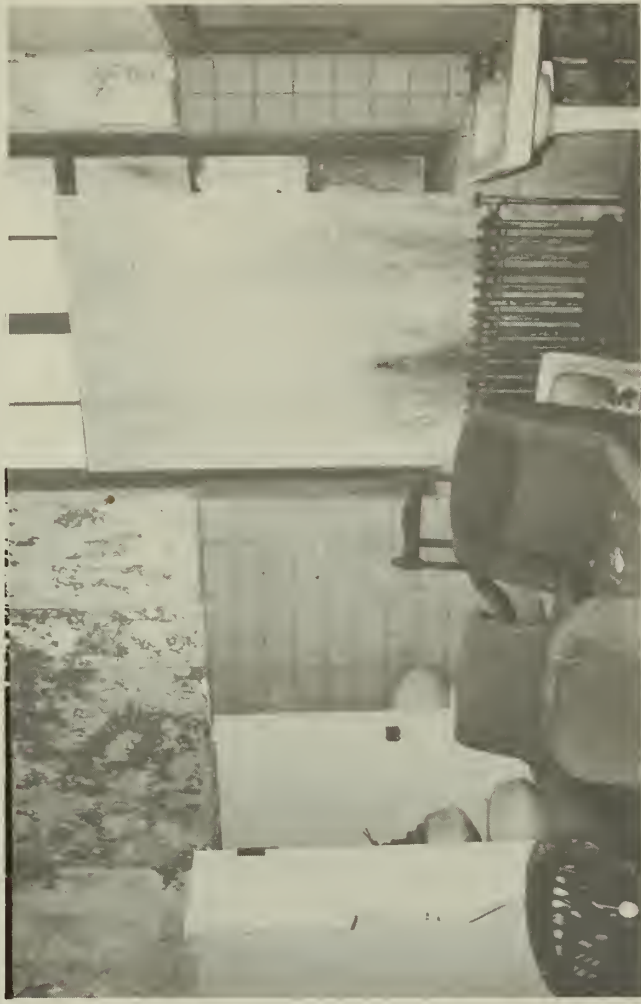
ROOM NO. 112

HEATING/ VENTILATION PLUMBING:	☒ Radiators ☐ Vents/Fans ☒ Sink/Toilet/Urinal ☐ Other:	☐ Intact ☐ Intact ☐ Intact ☐ Intact ☒ Destroyed ☒ Destroyed ☒ Destroyed ☒ Destroyed	1911-1923 1924-1933 1934-present In question	1 sink - pipes and mounts for 2 more. 3 toilets.
MISCELLANEOUS:		☐ Good ☐ Fair ☐ Poor ☐ Destroyed	1911-1923 1924-1933 1934-present In question	Structural glass (white) toilet stalls. 1 rusted paper towel dispenser. wood frame for mirror - mirror missing.
SUMMARY:		☒ Good ☐ Fair ☐ Poor ☐ Destroyed	1911-1923 1924-1933 1934-present In question	ARCHITECTURAL SIGNIFICANCE: ☐ Most ☐ Some ☒ Minor ☐ Negligible

PHOTOGRAPHS: ① View Northwest ② View South ③ View West

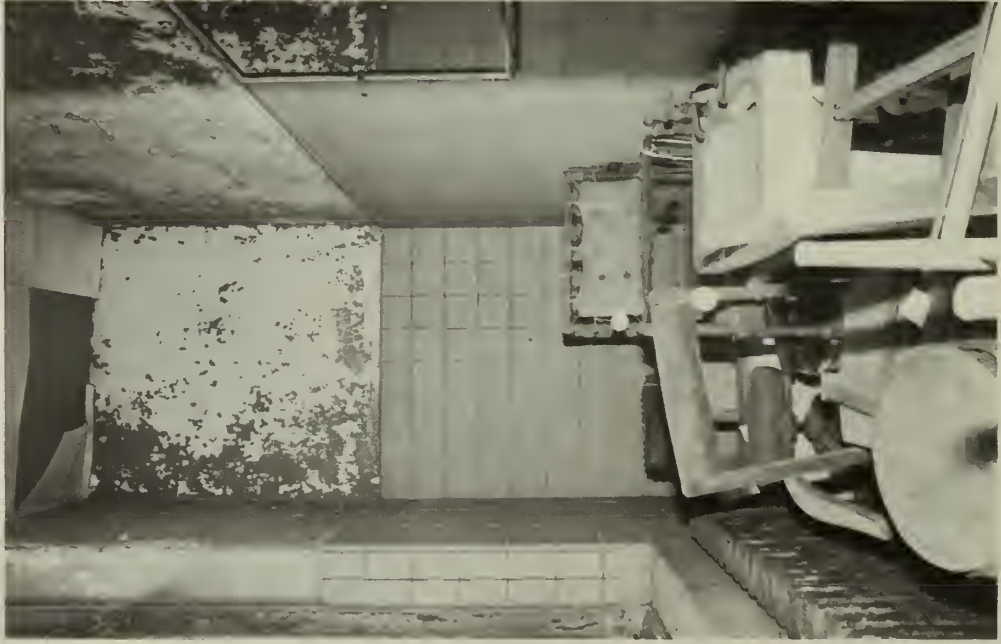
ROOM NO. 113A

PHOTOGRAPHS: ① View West

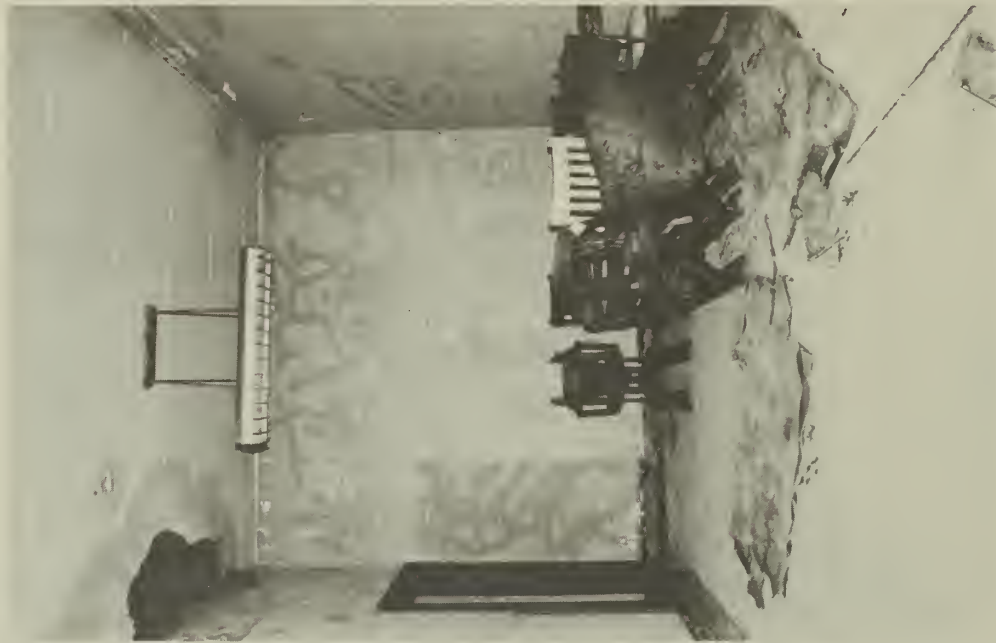
ROOM NO. 114

FINISHES:	CONDITION:	DATE:	NOTES:
FLOOR:	☒ Tile/Concrete ☒ Resilient ☐ Wood ☐ Other:	☐ Good ☐ Fair ☐ Poor ☒ Destroyed	☐ 1911-1923 ☐ 1924-1933 ☒ 1934-present ☐ In question	
BASE:	☒ Tile/Concrete ☒ Resilient ☐ Wood ☐ Other:	☐ Good ☐ Fair ☐ Poor ☒ Destroyed	☐ 1911-1923 ☐ 1924-1933 ☒ 1934-present ☐ In question	
WALLS:	☒ Plaster ☐ Partitions ☐ Tile Wainscot ☐ Other:	☒ Good ☐ Fair ☐ Poor ☒ Destroyed	☐ 1911-1923 ☐ 1924-1933 ☒ 1934-present ☐ In question	
CEILING:	☒ Plaster ☐ Acoustic panels ☐ Cove ☐ Other:	☐ Good ☒ Fair ☐ Poor ☒ Destroyed	☐ 1911-1923 ☐ 1924-1933 ☒ 1934-present ☐ In question	Water staining + missing panels near E. wall.
DOORS/ OPENINGS:	☒ Wood/Glass Panelled ☒ Wood Veneer ☐ Galvanized Metal ☐ Other:	☒ Good ☐ Fair ☐ Poor ☒ Destroyed	☐ 1911-1923 ☐ 1924-1933 ☒ 1934-present ☐ In question	Windows broken and boarded over.
LIGHTING:	☐ Incandescent/Type A ☐ Incandescent/Type B ☐ CML/Sconce ☒ Other: Fluorescent	☐ Intact ☐ Intact ☐ Intact ☐ Intact ☒ Destroyed ☐ Destroyed ☐ Destroyed ☐ Destroyed	☐ 1911-1923 ☐ 1924-1933 ☒ 1934-present ☐ In question

① View North

② View South

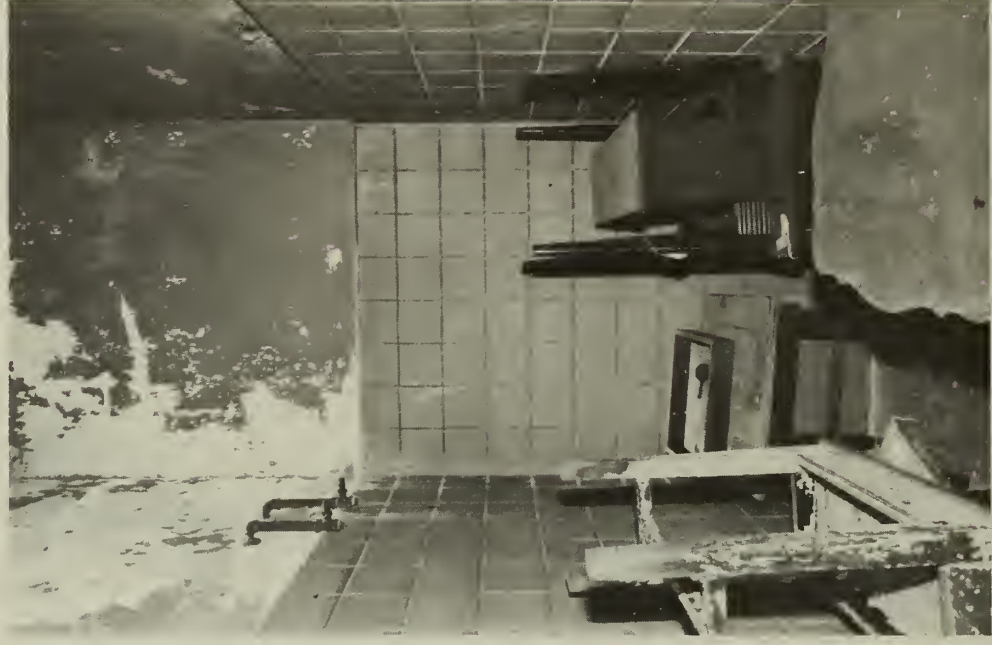
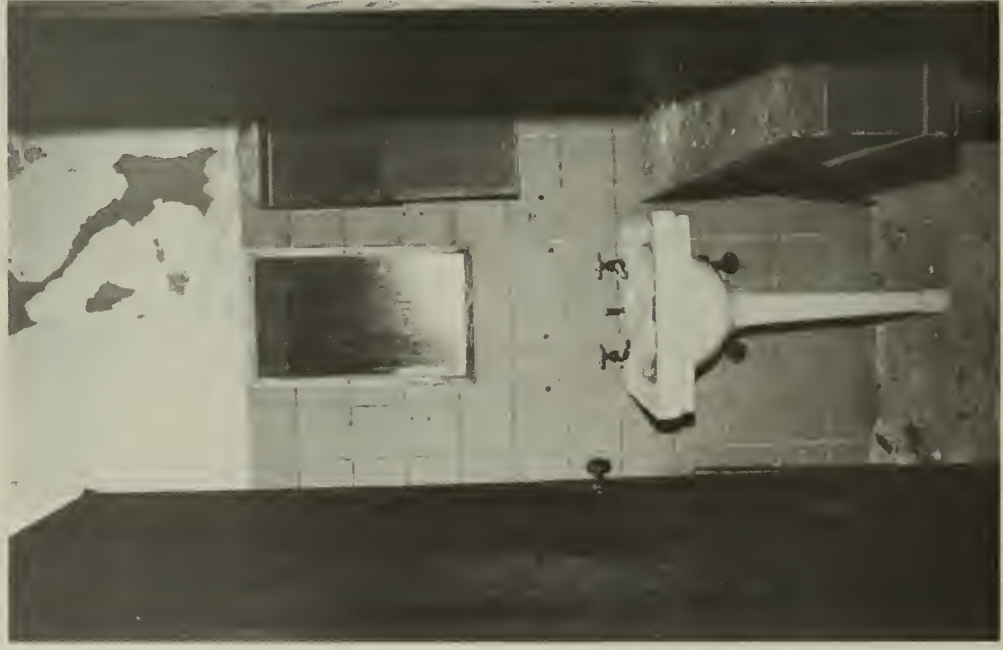
ROOM NO. 116B

ELLIS ISLAND				EXISTING CONDITION SURVEY				Immigrant Building				page: 504			
ROOM NO: 116B		LAST KNOWN USE: Bathroom		SQUARE FEET: 43		CEILING HEIGHT:		DATE: 16 Dec. 1985							
		FINISHES:		CONDITION:		DATE:		NOTES:							
FLOOR:		☒ Tile/Concrete ☐ Resilient ☐ Wood ☐ Other:		☒ Good ☐ Fair ☐ Poor ☐ Destroyed		1911-1923 1924-1933 1934-present In question		Square beige mat tile.							
BASE:		☒ Tile/Concrete ☐ Resilient ☐ Wood ☐ Other:		☒ Good ☐ Fair ☐ Poor ☐ Destroyed		1911-1923 1924-1933 1934-present In question									
WALLS:		☐ Plaster ☐ Partitions ☒ Tile Wainscot ☐ Other:		☒ Good ☐ Fair ☐ Poor ☐ Destroyed		1911-1923 1924-1933 1934-present In question									
CEILING:		☒ Plaster ☐ Acoustic panels ☐ Cove ☐ Other:		☐ Good ☐ Fair ☒ Poor ☐ Destroyed		1911-1923 1924-1933 1934-present In question									
DOORS/ OPENINGS:		☒ Wood/Glass Panelled ☒ Wood Veneer ☐ Galvanized Metal ☐ Other:		☒ Good ☐ Fair ☐ Poor ☐ Destroyed		1911-1923 1924-1933 1934-present In question				chain with bulb, shade destroyed.

PHOTOGRAPHS: ① View East

② View South

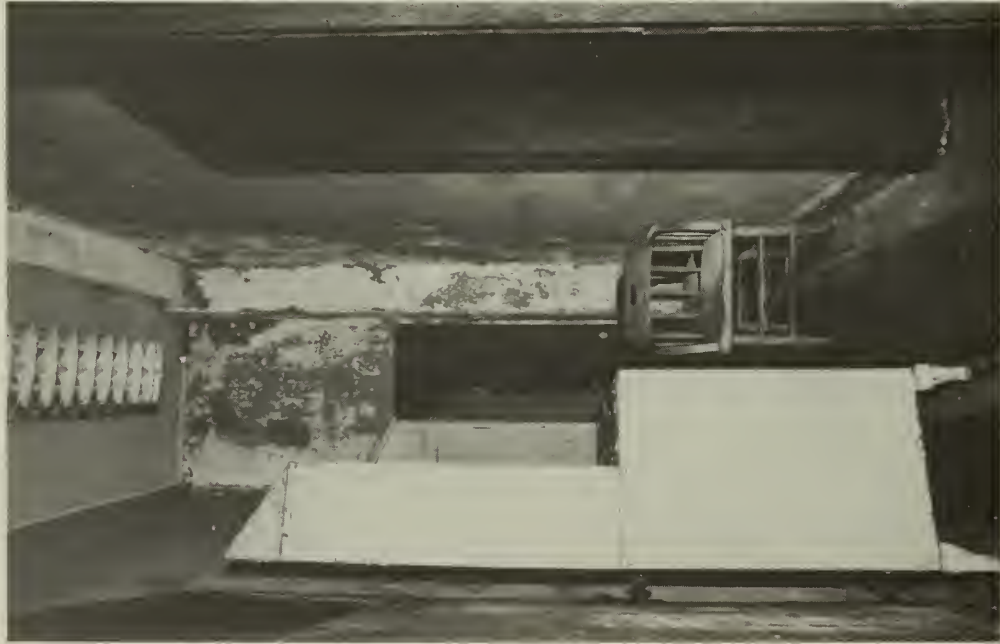
ROOM NO. 117A

ROOM NO: 117A		LAST KNOWN USE: Storage Closet		SQUARE FEET: 47	CEILING HEIGHT:	DATE: 16 Dec. 1985
		FINISHES:	CONDITION:	DATE:	NOTES:	
FLOOR:	☒ Tile/Concrete ☒ Resilient <i>rolled</i> ☐ Wood ☐ Other:	☒ Good ☒ Fair ☐ Poor ☐ Destroyed	☐ 1911-1923 ☒ 1924-1933 ☐ 1934-present ☐ In question			
BASE:	☒ ~~Tile~~ Concrete ☐ Resilient ☐ Wood ☐ Other:	☒ Good ☐ Fair ☐ Poor ☐ Destroyed	☐ 1911-1923 ☐ 1924-1933 ☒ 1934-present ☐ In question			
WALLS:	☒ Plaster ☐ Partitions ☐ Tile Wainscot ☐ Other:	☒ Good ☐ Fair ☐ Poor ☐ Destroyed	☐ 1911-1923 ☐ 1924-1933 ☒ 1934-present ☐ In question			
CEILING:	☒ Plaster ☐ Acoustic panels ☐ Cove ☐ Other:	☒ Good ☐ Fair ☐ Poor ☐ Destroyed	☐ 1911-1923 ☐ 1924-1933 ☒ 1934-present ☐ In question			
DOORS/ OPENINGS:	☒ Wood/Glass Panelled ☒ Wood Veneer 2 ☐ Galvanized Metal ☐ Other:	☐ Good ☐ Fair ☐ Poor ☐ Destroyed	☐ 1911-1923 ☐ 1924-1933 ☒ 1934-present ☐ In question			
LIGHTING:	☐ Incandescent/Type A ☐ Incandescent/Type B ☐ CML/Sconce ☒ Other: <i>fluorescent</i>	☐ Intact ☐ Intact ☐ Intact ☐ Intact ☐ Destroyed ☐ Destroyed ☐ Destroyed ☐ Destroyed	☐ 1911-1923 ☐ 1924-1933 ☒ 1934-present ☐ In question

PHOTOGRAPHS: ① View North

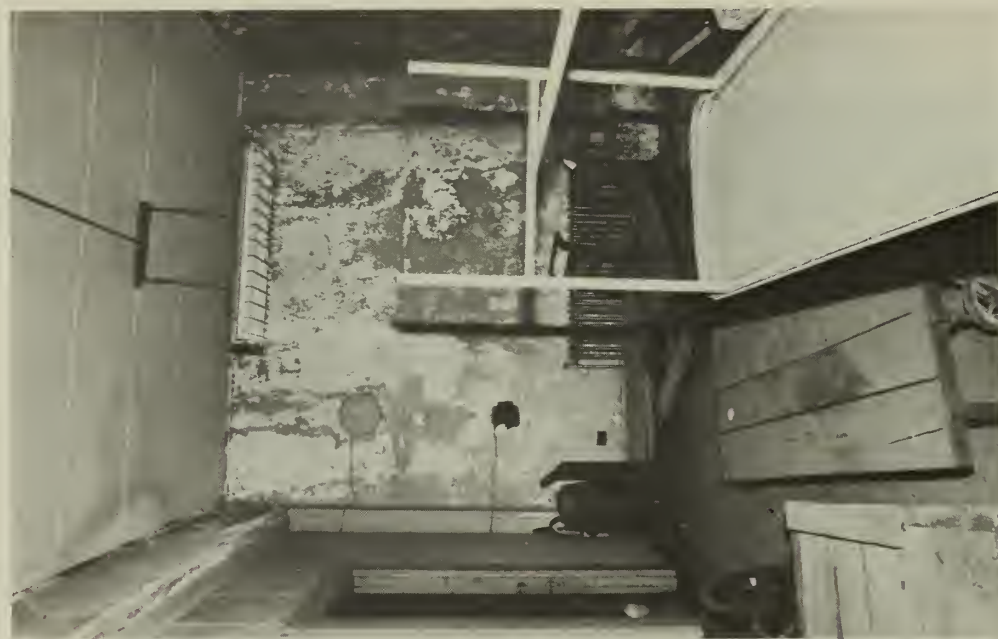
ROOM NO. 501

FINISHES:	CONDITION:	DATE:	NOTES:
FLOOR:	☒ Tile/Concrete ☐ Resilient ☐ Wood ☒ Other: <i>paved stone Terrazzo</i>	☒ Good ☐ Fair ☐ Poor ☐ Destroyed	☐ 1911-1923 ☐ 1924-1933 ☒ 1934-present ☐ In question	As in hallway, beige, black + white chips, 2' 6 1/2" X 2' 3 1/4" sections, Brass dividing strips.
BASE:	☐ Tile/Concrete ☐ Resilient ☒ Wood ☒ Other: <i>Terrazzo</i>	☒ Good ☐ Fair ☐ Poor ☐ Destroyed	☐ 1911-1923 ☐ 1924-1933 ☒ 1934-present ☐ In question	Wood @ partition wall (W). Terrazzo @ other 3 walls.
WALLS:	☒ Plaster ☒ Partitions ☐ Tile Wainscot ☐ Other:	☒ Good ☐ Fair ☐ Poor ☐ Destroyed	☐ 1911-1923 ☐ 1924-1933 ☒ 1934-present ☐ In question	best wall - bet. 501 and Hallway wood partition. E.N., S. walls plaster.
CEILING:	☒ Plaster ☐ Acoustic panels ☐ Cove ☐ Other:	☒ Good ☐ Fair ☐ Poor ☐ Destroyed	☐ 1911-1923 ☐ 1924-1933 ☒ 1934-present ☐ In question	
DOORS/ OPENINGS:	☐ Wood/Glass Panelled ☐ Wood Veneer ☐ Galvanized Metal ☐ Other:	☐ Good ☐ Fair ☐ Poor ☐ Destroyed	☐ 1911-1923 ☐ 1924-1933 ☒ 1934-present ☐ In question	Framed square opening (approx. 2' x 2') in partition wall (window, no glass).

PHOTOGRAPHS: ① View North ② View Southeast ③ View South

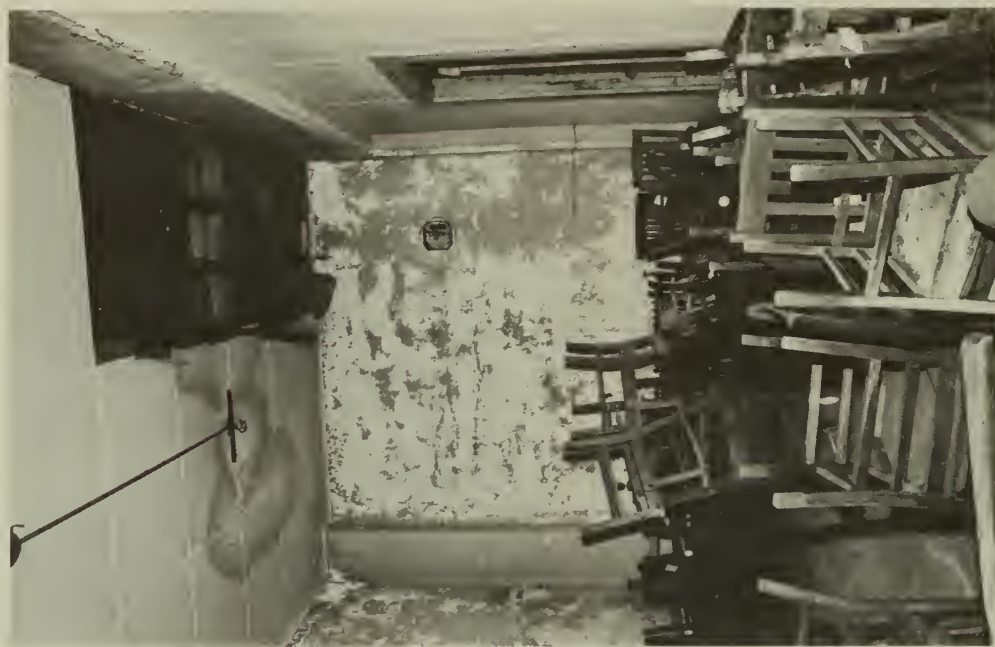
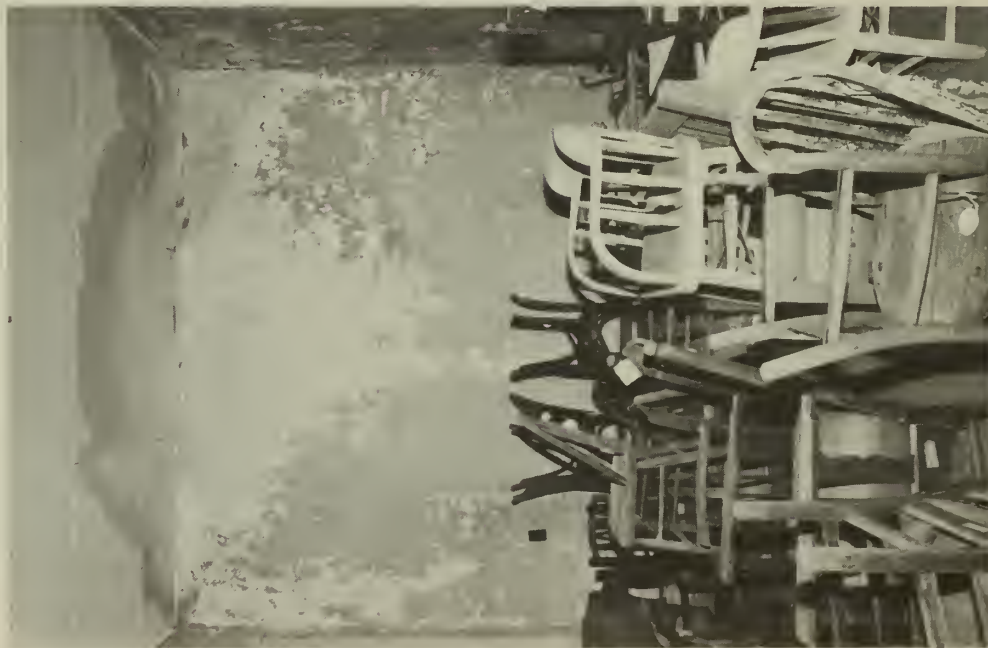
ROOM NO. 502

ROOM NO: 502	LAST KNOWN USE: Office	SQUARE FEET: 284	CEILING HEIGHT:	DATE: 16 Dec. 1985
FINISHES:		CONDITION:	DATE:	NOTES:
FLOOR:	☒ Tile/Concrete ☐ Resilient ☐ Wood ☒ Other: poured stone/terrazzo	☒ Good ☐ Fair ☐ Poor ☐ Destroyed	☐ 1911-1923 ☐ 1924-1933 ☒ 1934-present ☐ In question	As in hallways, beige, black + white chips, 2' 6 1/2" x 2' 3 1/4" sections, brass dividing strips.
BASE:	☒ Tile/Concrete ☒ Resilient ☒ Wood ☒ Other: terrazzo	☒ Good ☐ Fair ☐ Poor ☐ Destroyed	☐ 1911-1923 ☐ 1924-1933 ☒ 1934-present ☐ In question	Wood @ partition wall (w.) Terrazzo @ other 3 walls.
WALLS:	☒ Plaster ☒ Partitions ☒ Tile Wainscot ☐ Other:	☒ Good ☐ Fair ☐ Poor ☐ Destroyed	☐ 1911-1923 ☐ 1924-1933 ☒ 1934-present ☐ In question	W. wall, wood partition.
CEILING:	☒ Plaster ☒ Acoustic panels ☐ Cove ☐ Other:	☐ Good ☐ Fair ☐ Poor ☐ Destroyed	☐ 1911-1923 ☐ 1924-1933 ☒ 1934-present ☐ In question	Water stained, area of missing panels in SW corner.

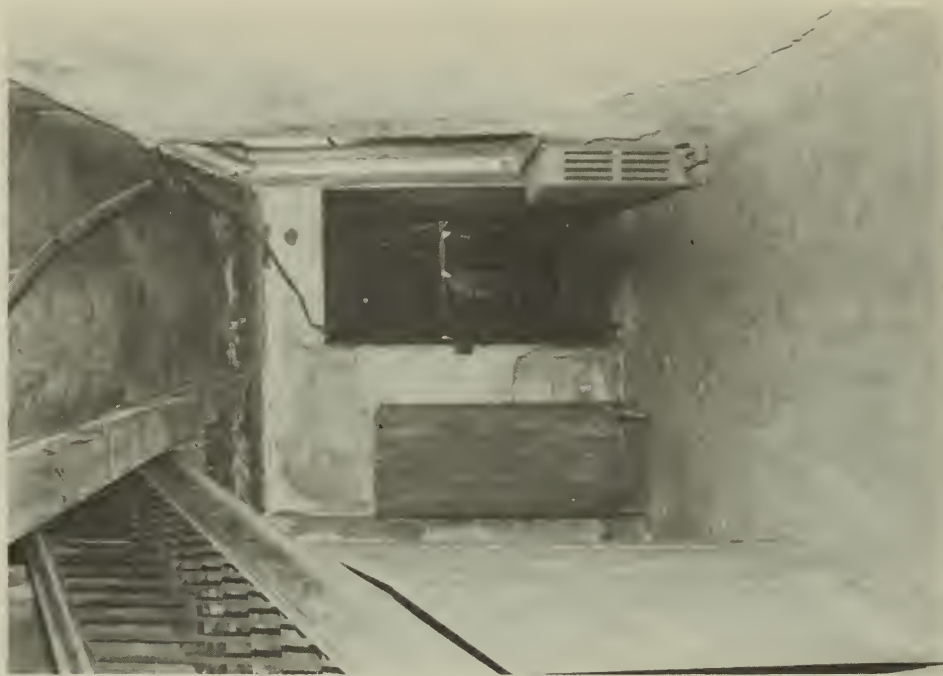
FINISHES:	CONDITION:	DATE:	NOTES:
FLOOR:	☒ Tiled Concrete ☒ Resilient ☐ Wood ☐ Other:	☐ Good ☐ Fair ☐ Poor ☒ Destroyed	☐ 1911-1923 ☐ 1924-1933 ☒ 1934-present ☐ In question	Remnants of resilient tile attached to concrete substructure.
BASE:	☐ Tile/Concrete ☐ Resilient ☐ Wood ☐ Other:	☐ Good ☐ Fair ☐ Poor ☒ Destroyed	☐ 1911-1923 ☐ 1924-1933 ☒ 1934-present ☐ In question	
WALLS:	☒ Plaster ☐ Partitions ☐ Tile Mainscot ☐ Other:	☒ Good ☐ Fair ☐ Poor ☒ Destroyed	☐ 1911-1923 ☐ 1924-1933 ☒ 1934-present ☐ In question	Some exposure of structural tile.
CEILING:	☒ Plaster ☐ Acoustic panels ☐ Cove ☐ Other:	☐ Good ☐ Fair ☐ Poor ☒ Destroyed	☐ 1911-1923 ☐ 1924-1933 ☒ 1934-present ☐ In question	
DOORS/OPENINGS:	☒ Wood/Glass Panelled ☒ Wood Veneer 2 ☐ Galvanized Metal ☐ Other:	☐ Good ☐ Fair ☐ Poor ☒ Destroyed	☐ 1911-1923 ☐ 1924-1933 ☒ 1934-present ☐ In question	2-light casement window w/ rusted metal sill. Dark stain on wood frame.

② view West

PHOTOGRAPHS: ① view East

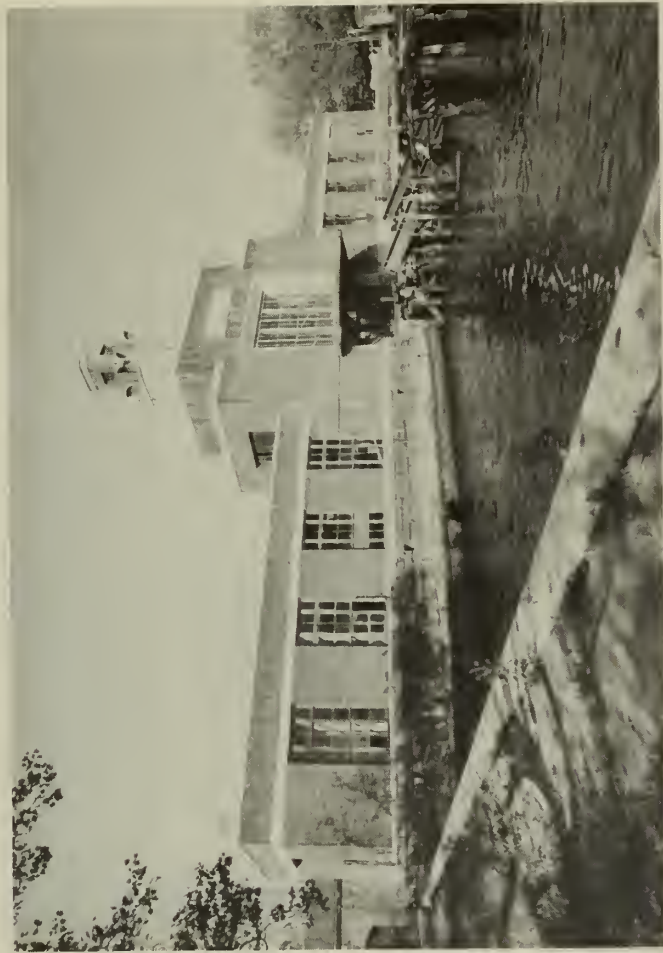
GOOD	XXX	FAIR		POOR		DESTROYED	
GOOD	XXX											
FAIR												
POOR												
DESTROYED

East elevation, view
southeast.

East elevation, view northwest.
